HMAS TOBRUK

JOINT COMMITTEE OF PUBLIC ACCOUNTS

REPORT 223

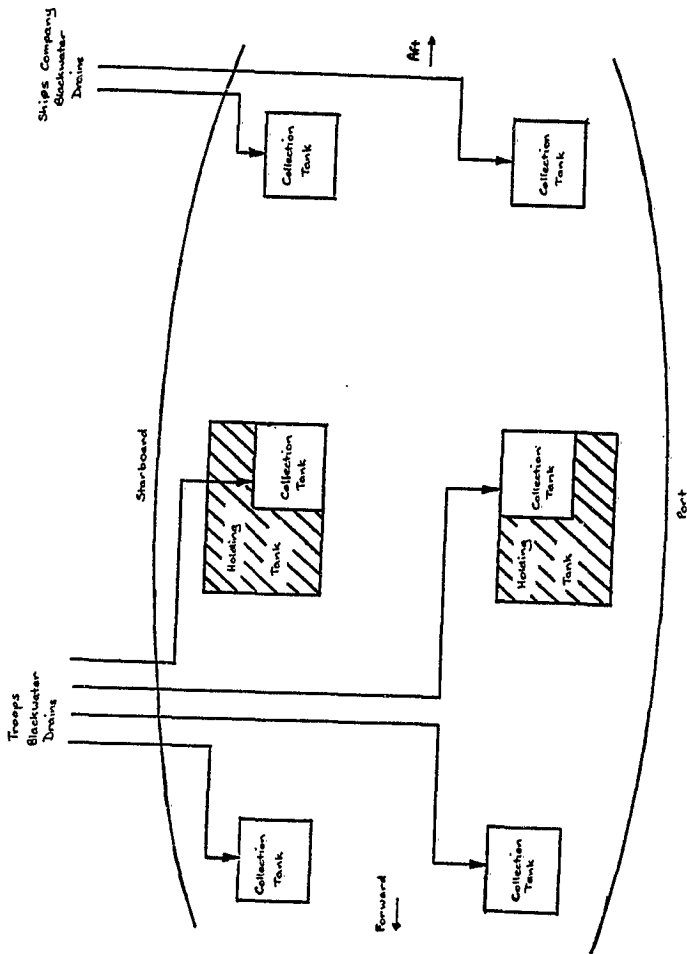
DIAGRAM 3 - General Outline of HMAS Tobruk's Sewerage System

centre line and, in effect, form two similar interconnected systems. I shall consider only one system and, in passing, would mention that it was the port side system which was involved in the accident (the death of NRC Dax). It could have been either. Bathroom, laundry and galley drains, called greywater drains, go directly to the holding tanks while the toilet, or heads' drains, called blackwater drains, were to go to the collection tanks in the first instance. The design also called for all ship's company blackwater drains to go to the aft collection tanks, leaving the other four for embarked troops. This would allow the four tanks designated for troops' use to be shut down when there are no troops on board. Since the accident (death) it has been established that several ship's blackwater drains were directed by the shipbuilder to the midships collection tanks, including the port midships tank involved in the accident. This would mean that the tank would slowly collect human wastes and generate gases of decomposition without the ship being aware of it.

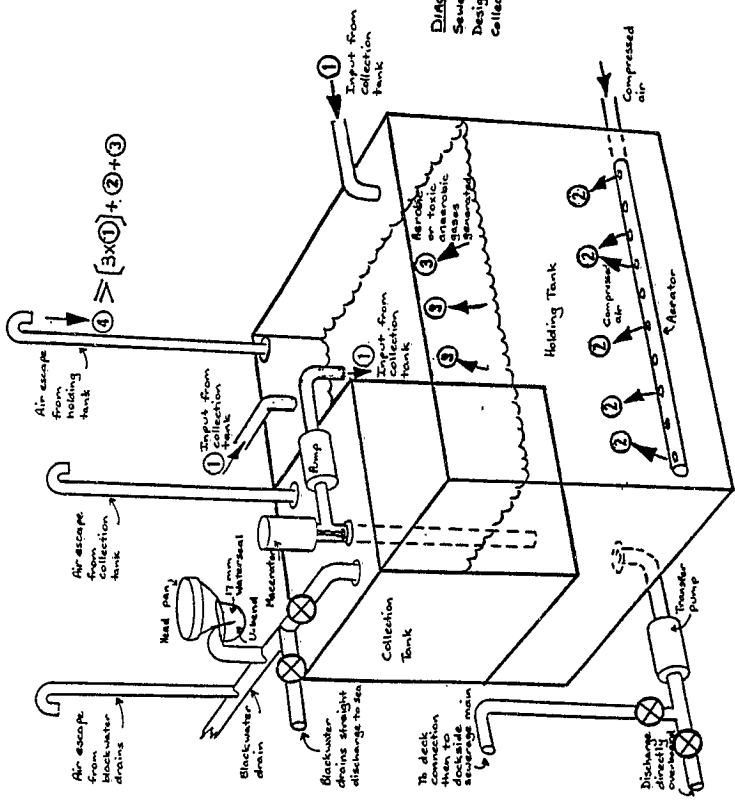
DIAGRAM 4: HMAS Tobruk's Sewerage System: Original Design of Holding and Collection Tank

Turning now to the tanks in question (see Diagram 4) as is typical of the entire system, we have the various heads pans, discharging via U-bends and water-seals to the collection tank. Just like toilet pans in one's own home, the blackwater drain needs an air escape on it acting as a siphon breaker, to stop the water-seal from being sucked out by the venturi effect of water passing by in the combined blackwater drain. In these pans in HMAS 'Tobruk' the water-seal is only 17 millimetres deep, in order to minimise the amount of flush water necessary to overcome the seal when flushing away waste. The collection tank also has an air escape on it to compensate for the inflow from the blackwater drains. These blackwater drains can, of course, be directed straight overboard without passing through the sewerage treatment plant at all and this would always be the case in the open sea, outside the 12-mile limit specified by the International Maritime Organisation. The midships collection tanks' air escapes were originally intended to go directly to the upper deck but because of their proximity to the holding tank air escapes, approval was given to combine them in the interests of simplicity (see Diagram 5). It is now believed that this modification contributed to the accident. The sewerage is pumped from the collection tank to the holding tank via a macerator, or chopping blade, which ensures that there are no lumpy solids passed across to the holding tanks. There are, of course, up to three macerator pumps discharging to each of the holding

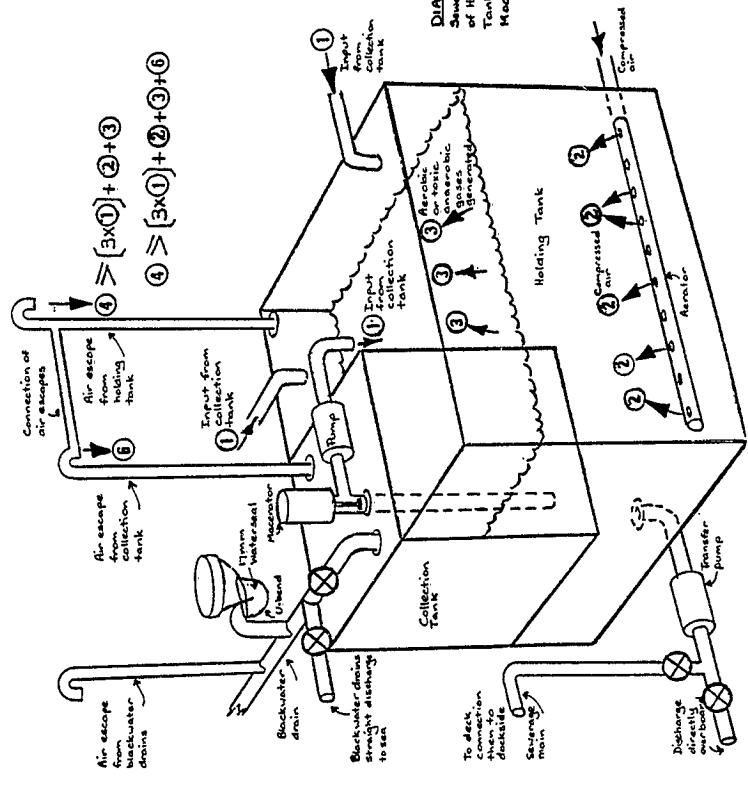
DIAGRAM 5: HMAS Tobruk's Sewerage System: Operation of Holding and Collection Tank after First Design Modification

tanks at any one time. There is a requirement that the contents of the holding tanks should be constantly aerated with compressed air being supplied from a special compressor in the engine room. If copious quantities of air are not supplied constantly the chemistry of the microbiological decomposition which occurs in the holding tanks will be changed from aerobic to anaerobic. Gases are generated in both circumstances but they are different gases and are almost certain to be toxic when decomposition occurs in the absence of free oxygen. As I indicated earlier, the ship did not fully understand the plant and only operated the aerator compressor intermittently. The holding tank also has an air escape, which as originally designed, had to cope with the volume of air displaced by the discharge of up to three macerator pumps, plus the aerating air itself, plus the volume of product gases being generated within the decomposing sewerage.

Our calculations showed that the holding tank vent pipe did have sufficient capacity to cope with three times the inflow of the macerator pumps plus the aerating air plus the generated gases without raising the pressure in that tank significantly, or at all (ie. $4(3 \times 1) + 2 + 3$ on Diagrams 4, 5 and 6). The first modification that occurred was to connect the vent pipe from the port macerator tank to the port holding tank vent pipe so that the port holding tank vent pipe had the additional duty (no.6 on Diagram 5) which had previously been the duty of the macerator tank vent. Our calculations showed that this combined vent pipe is still big enough to cope with the addition of that displaced vapour or gas or air without creating an overpressure in the tank (ie. $4(3 \times 1) + 2 + 3 + 6$ on Diagrams 5 and 6). That first modification, of course, occurred during building. The next modification dates from August 1981. In this case, that same vent pipe had been connected to it a similar combined vent from the other side of the ship (see 7 on Diagram 6). The two then ran together up the starboard kingpost. So in effect, the new piece of pipe had to cope with twice the load that the individual tanks had to cope with earlier and our calculations have shown that it could not do so without a back pressure building up inside the vapour space of the holding tank (ie. $4(3 \times 1) + 2 + 3 + 6 + 7$ on Diagram 6). That pressure then had a path of course up to the atmosphere but if it were sufficient - and it was - it was able to track

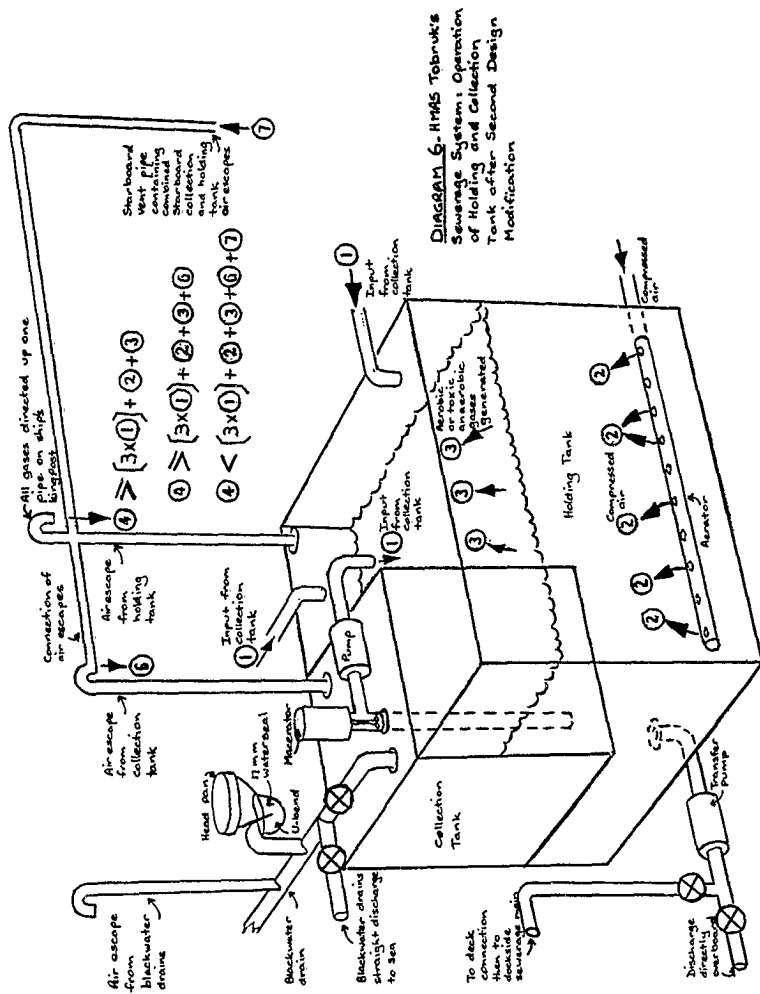
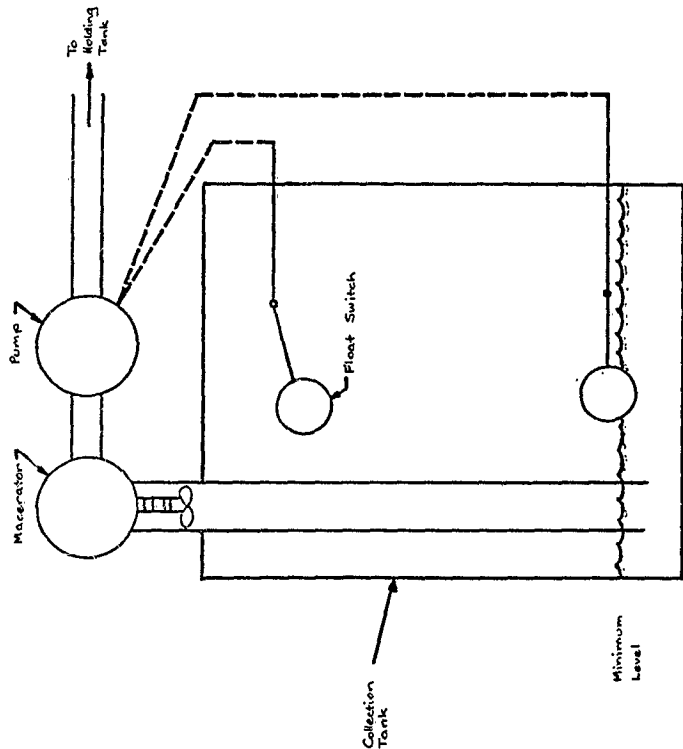
DIAGRAM 1 - HMAS Tebruki Sewerage System : Float Switch Operation

back along that path to the macerator tank and from the macerator tank back through the blackwater drain and bubble out past a 17-millimetre seal. That 17 millimetres, of course, is the critical pressure.
