HMAS TOBRUK Response

227TH REPORT

HMAS TOBRUK - RESPONSE

FINANCE MINUTE ON THE COMMITTEE'S 223RD REPORT -

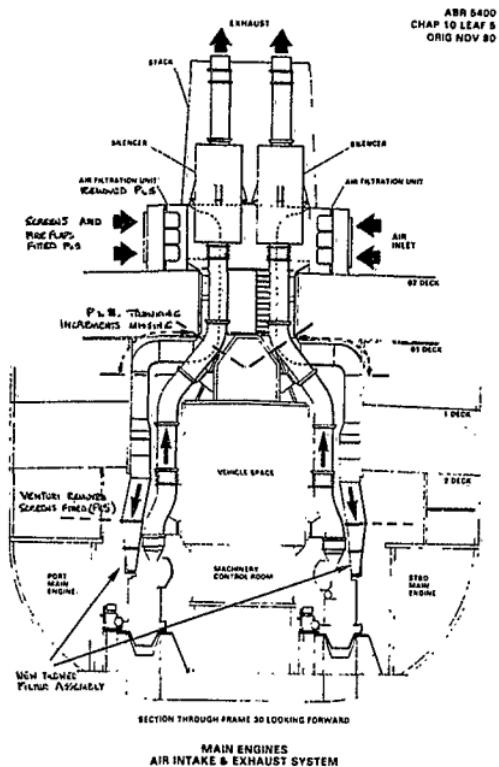
SECTION AT FRAME 30

26. As the turbo blower inlet trunking is bounded on one side by accommodation bulkheads through three decks, considerable resonance was generated and transmitted to accommodation causing acute discomfort when the ship was underway. Accommodation areas had been designated 'Noise Dangerous'.

27. A recommendation was made to FHO to remove the M/E turbo blower suction from 02 deck. By substituting an engine mounted blower filter assembly a two fold result would be achieved:

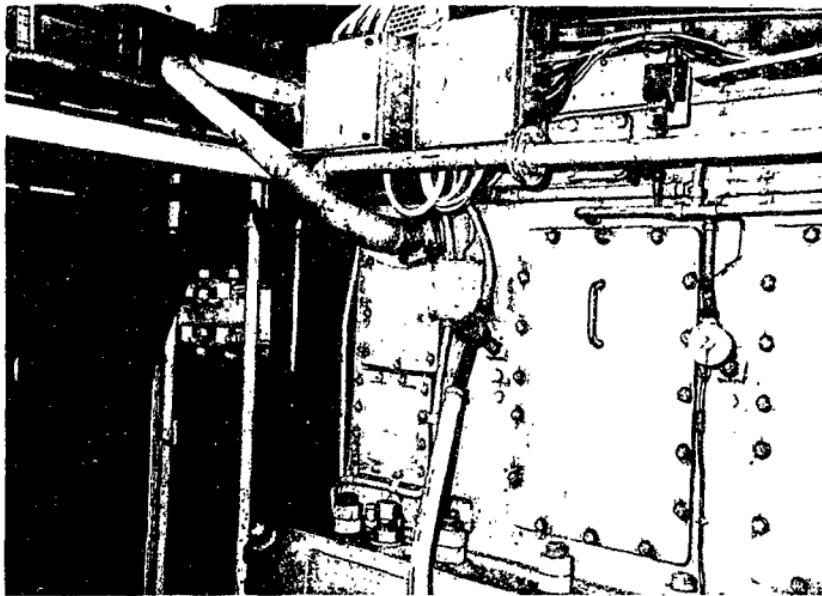
Crankcase Extraction

51. For three years of operation, HMAS TOBRUK had been discharging main engine lubricating oil via crankcase breathers terminating on both sides of the funnel casing. The problem had been accentuated by the fitting of a crankcase extraction fan for each engine (not usually fitted in medium speed engine installations). Due to an incorrect pipe run, commonality between the crankcase breather and the Gravier oil mist detection unit had been introduced leading to a potentially dangerous situation caused by back flooding (and fouling) of the unit. A design fault was also found in the main engine crankcase extraction pipe at the entablature take off, the internal pipe suction being too close to the piston cooling oil gallery return. Blanks have been fitted to divorce the Gravier system from the crankcase extraction line and the mist detection sample now discharges into the MMR atmosphere. The crankcase extraction fans have been shut down since February 1984 without any obvious signs of entablature leaks.
