HMAS TOBRUK

JOINT COMMITTEE OF PUBLIC ACCOUNTS

REPORT 223

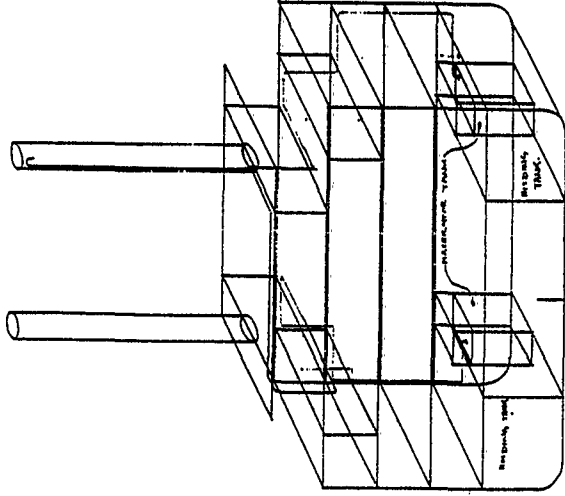
GAS PATH MODEL.

ISOMETRIC SECTION OF FRAME S4 TO FRAME 44 LEAK IN FWD. SHOWING THE HOLDING TANK | CENTRIFUGAL-WATER/VENT TANK VENT SYSTEM.
